**The MacFarlan House:
A Survey of an Okie-Designed Work in Progress**

Rebecca Angeline Geist

Historic Preservation

1998

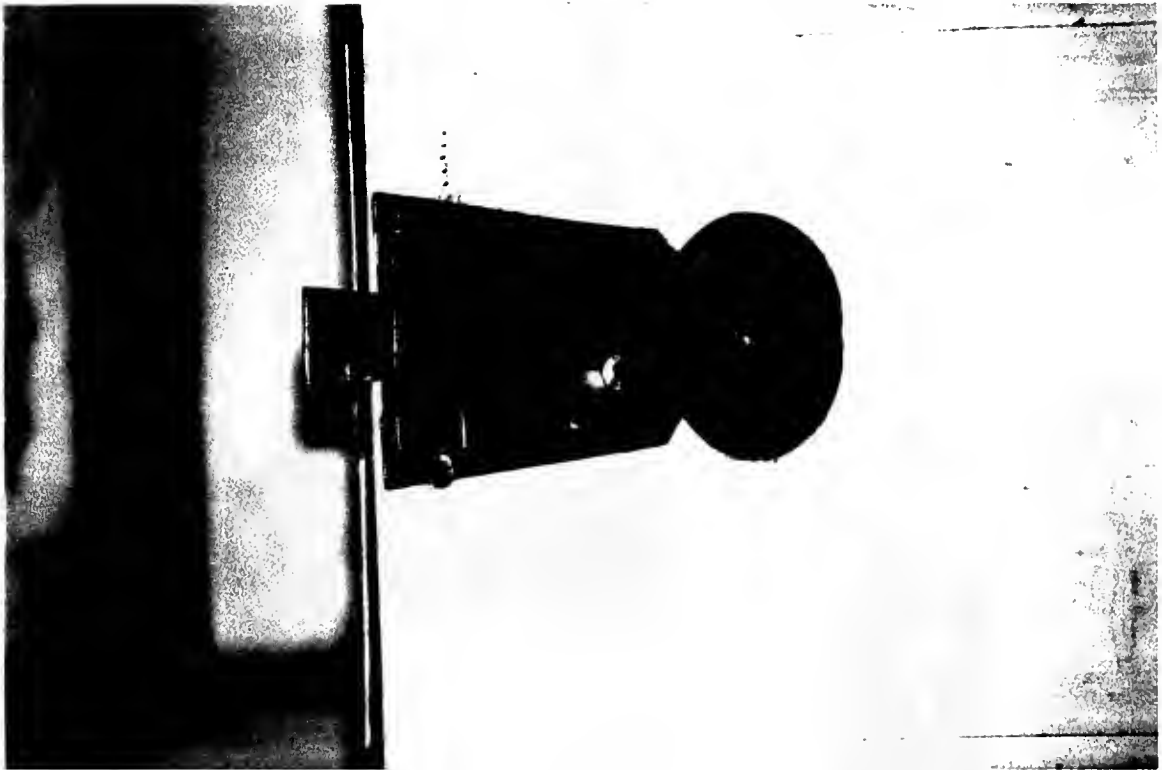
Figure 4.10 This photograph shows one of the pre-existing grained doors of the second floor which Okie chose to keep. Here, Okie has removed the butt hinges which were original to the door and applied H hinges.

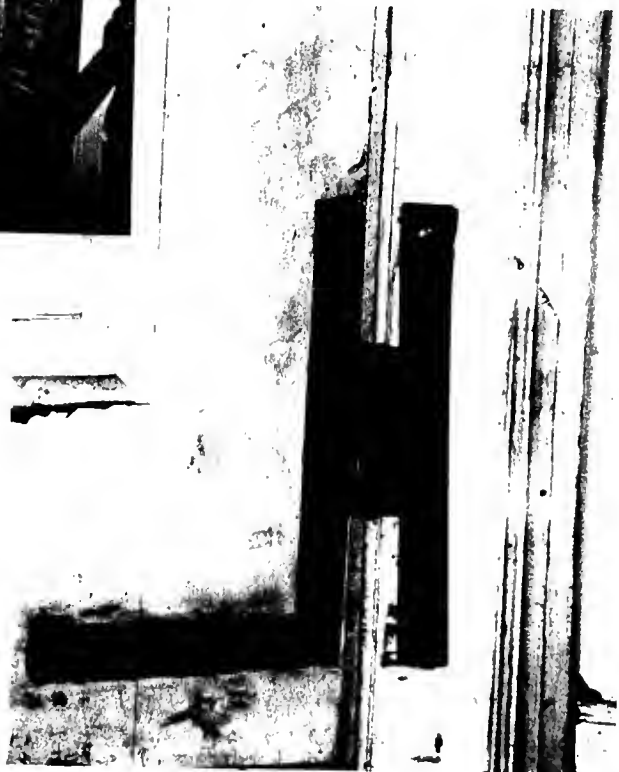
Figure 4.11 These HL hinges were used on several interior doors throughout the house.

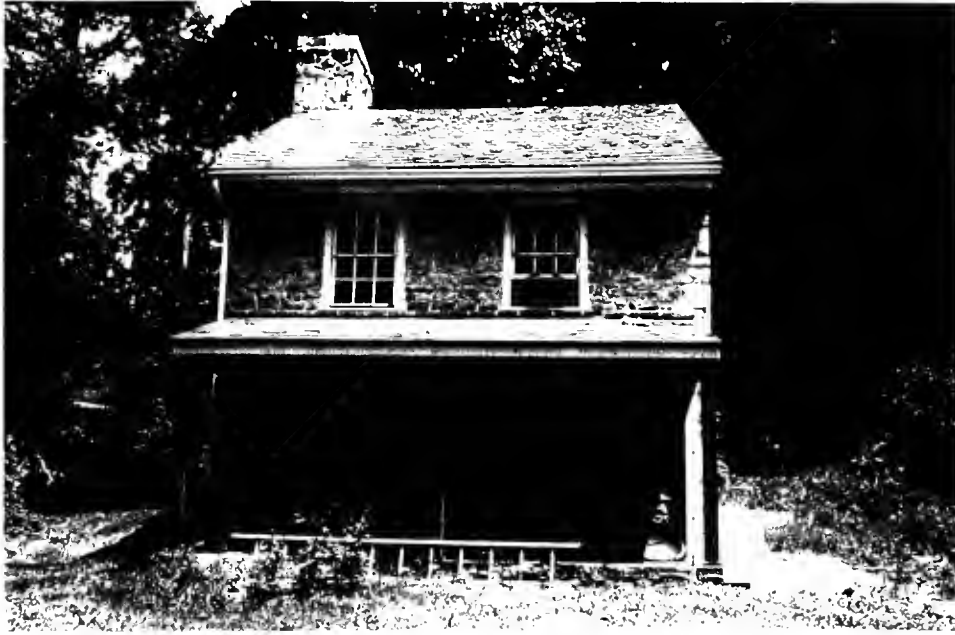
Figure A.3 Tenant House at MacFarlan Farm. Designs for additions and alterations to this house were submitted by Charles T. Okie, but not constructed.

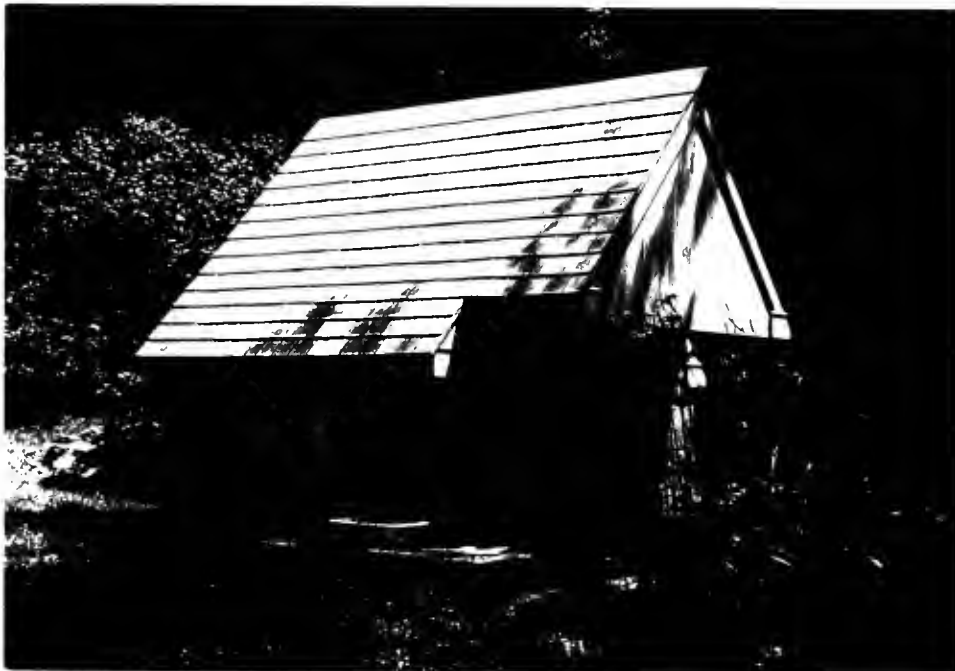
Figure A.4 Springhouse at tenant house designed by R. Brognard Okie in the 1940's. This springhouse replaced an existing one. The hardware is all of wood.

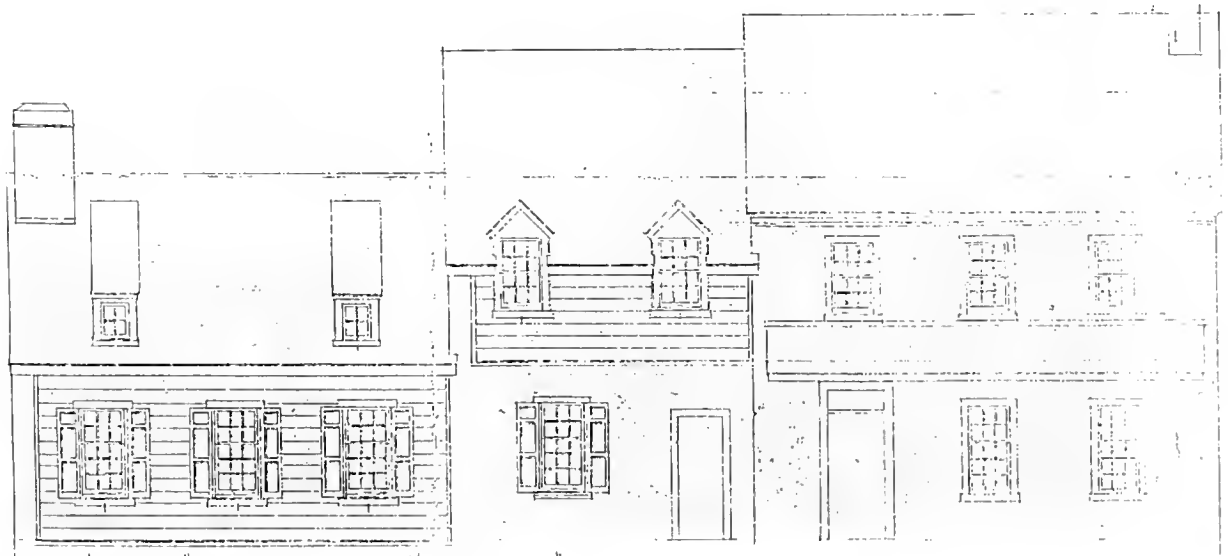
Figure A.6 Front Elevation submitted by Charles T. Okie to Colonel MacFarlan of North Farm house (Courtesy of David Nace.)

Figure A.5 North Farm, also called the Lang Farm as it exists today. Charles T. Okie submitted drawings to Colonel MacFarlan for an addition and alterations to this house which were never constructed.

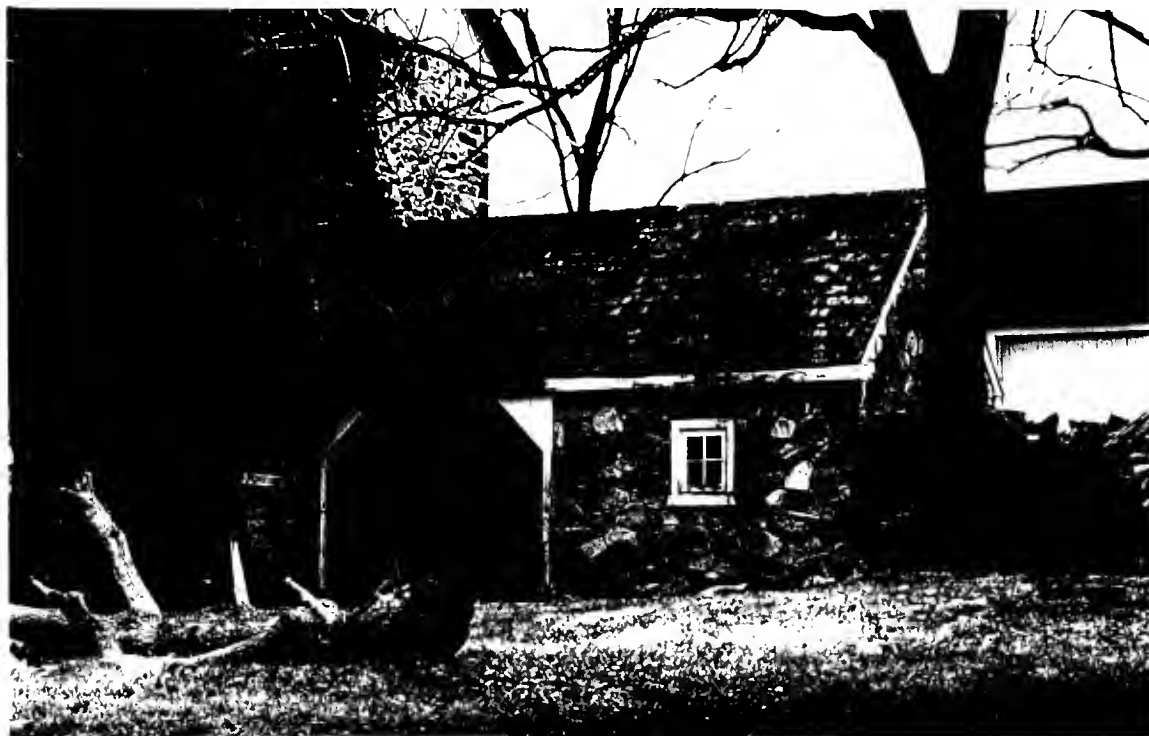
Figure A.7 Tool Shed designed by Charles T. Okie in the early 1960's.

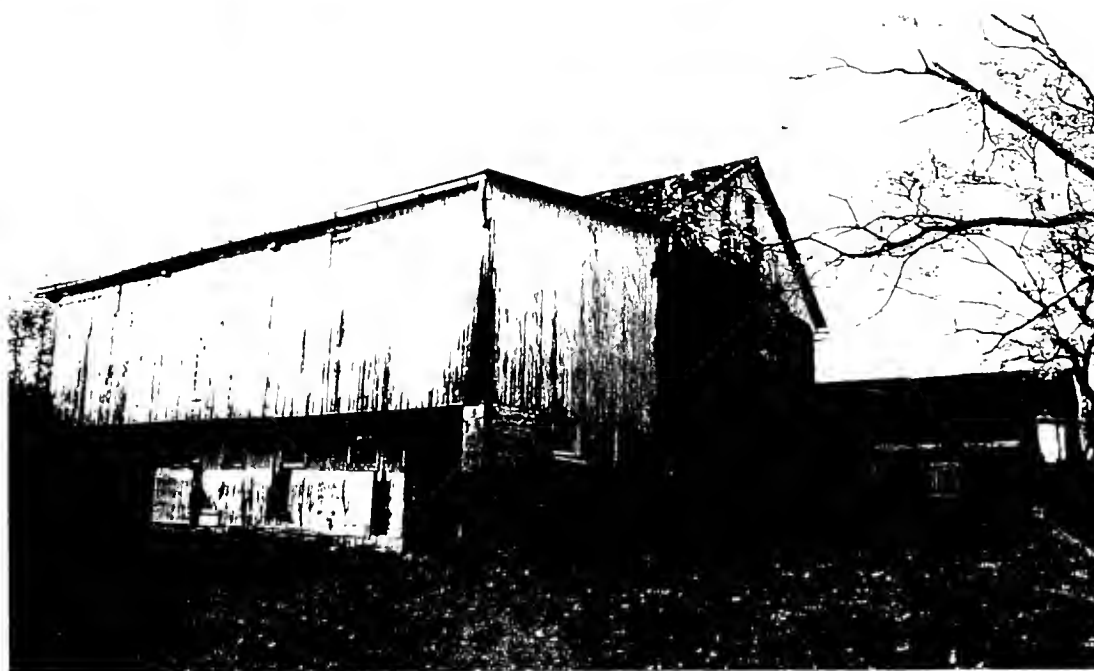
Figure A.8 Barn This barn may have been partly designed by Charles T. Okie as a few detail have been found regarding its doors and hardware, but no drawings to indicate this is true have been found.
